Manhole Inspection Summary

Manhole # S11U__003MH

Insp Date: **2/2/09 12:43 PM**

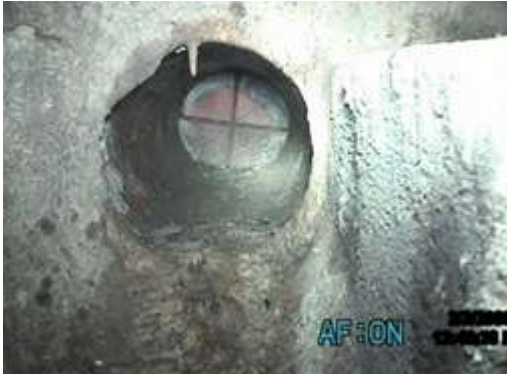
Misc.

abandoned pipe @ 3

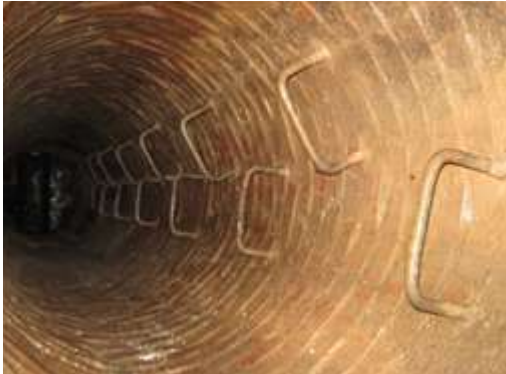
Defect 1

Steps Count: **21** Missing: **0** ☒ **Corroded**

Corroded Steps

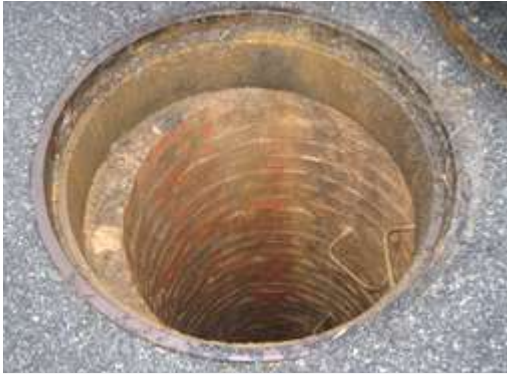
Defect 3

Frame Offset: **3.5** (in.) Condition: ☐ Sound ☐ Cracked ☒ **Leaks**

Frame Leaks

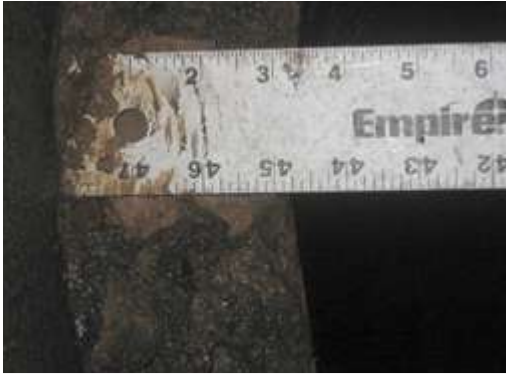
Defect 2

Frame Offset

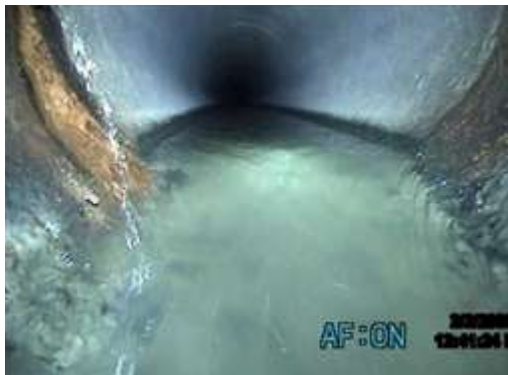
Defect 4

pipe seal infiltration-runner

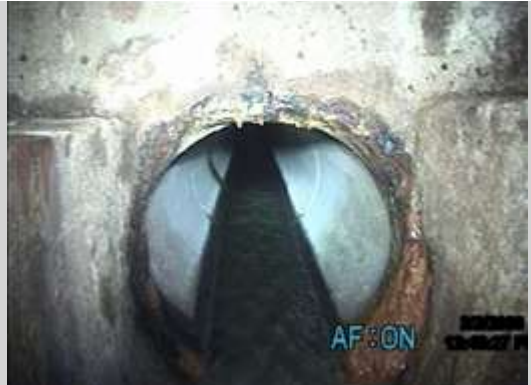
12 O'Clock Outflow

18 in. Circular Gravity Sewer
Pipe Out @ 12 O'Clock

Infiltration: **Weeper** Pipe Seal Cond: **Sound**

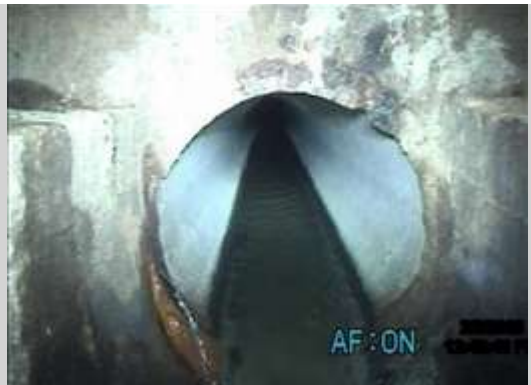
6 O'Clock Inflow

broken seal on pipe

Infiltration: **Runner** Pipe Seal Cond: **Cracked**
